# Megaroller Failed Bearing Indicator

## FBI Flinger – Technical Data

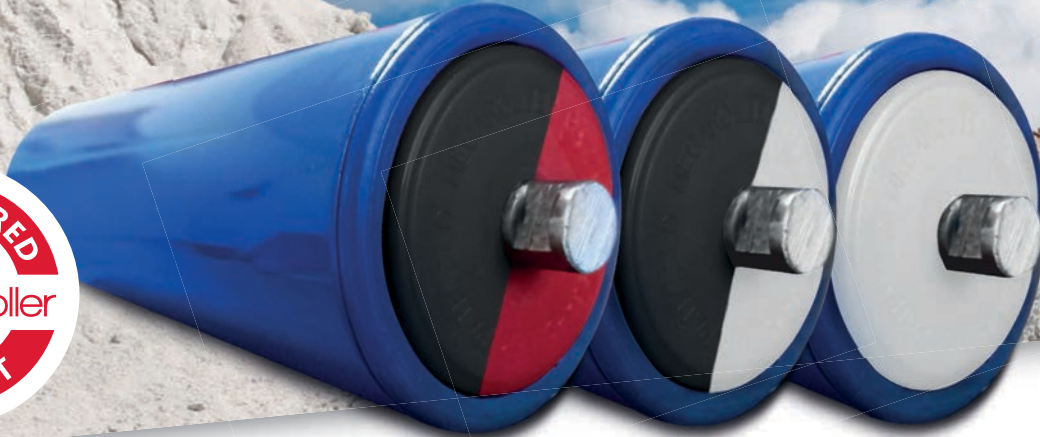
Standard Operation

Failure In Progress

Final Failure

The reason for the two colours is to improve the ease of monitoring, no longer needing expensive thermal cameras. Once the thermochromic coating reaches the designed temperature, it starts to turn opaque. A white base coat is painted underneath the thermochromic layer which means the flinger will turn white from our standard Royal Blue, Red or Black. The black coating is used for the non-permanent layer which activates at seventy degrees and indicates that idler change has become critical.
